Customer Letter
(Internal Reference: TSB PR92820)

Quality Improvement Action

- 1) Dräger Plus / PSS Series Lung Demand Valves (LDV)**
Manufactured date range: September 2017 through March 2018

March 6th, 2020

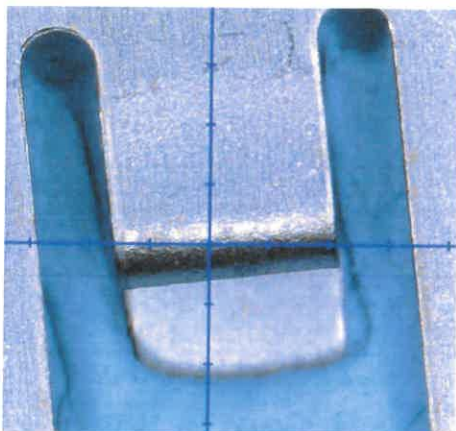
Normal Un-marked Spring

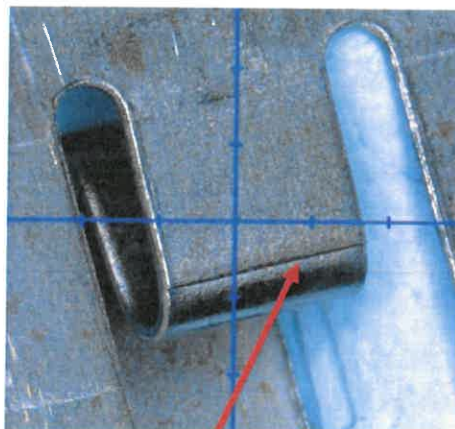
The manufacturing error has produced a score mark on the switch-off spring. The photos below show a normal un-marked spring, and a spring with the manufacturing error score mark. The LDV section view shows the position of the switch-off spring when fitted to the LDV.

Extensive testing of the manufacturing error marked springs have shown that the score mark will eventually reduce the design specified fatigue resistance of the spring. However, the score mark error will not affect the safe function of the LDV during use. The section below will explain the effects of the error. The expected service life of the product with the manufacturing error is estimated to be at least 4 to 7 years assuming normal and typical use.

Score Marked (Error) Spring

The switch-off spring is not available as a spare part therefore the repair will require the replacement of the Air Transfer Block (ATB) in the LDV, as well as the corresponding clamp and clip. After replacing the ATB a full LDV function test will be required

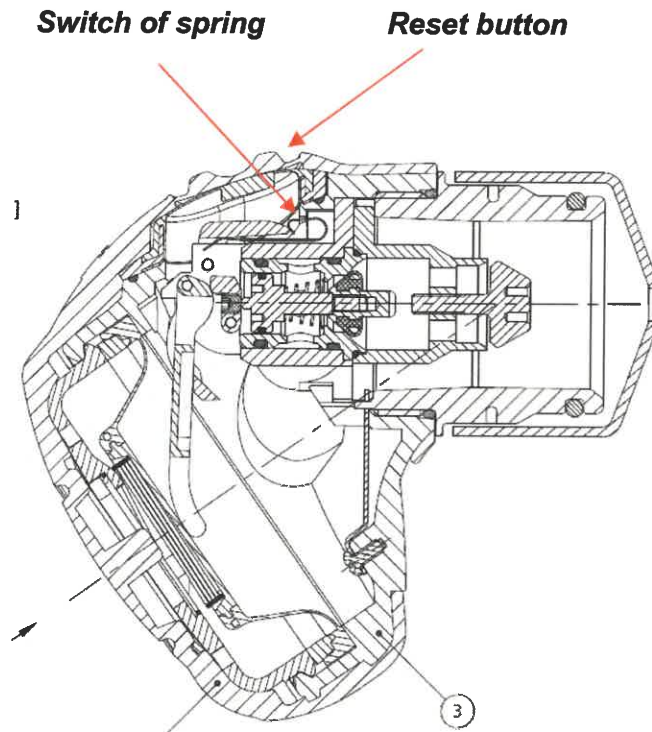
LDV cross-sectional view
