To: Miller SkyGrip Temporary Horizontal Lifeline System Distributors/End-Users

From: Honeywell Personal Protective Equipment

Date: May 11, 2021

Subject: IMMEDIATE MANDATORY INSPECTION NOTICE

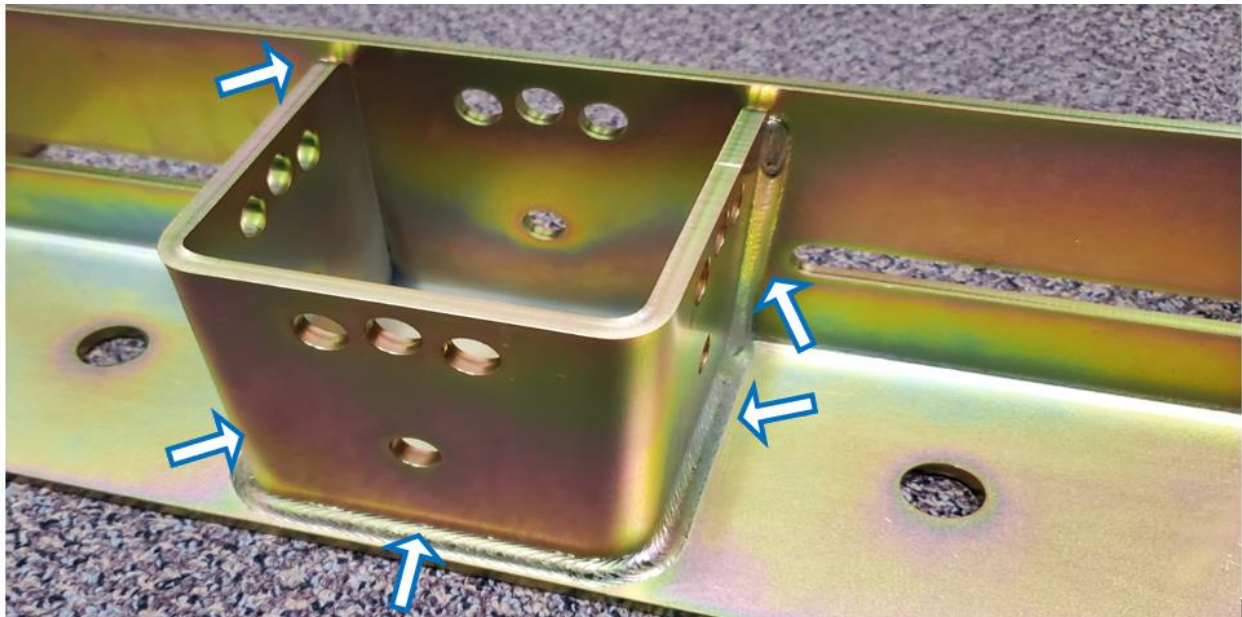
At Honeywell, our mission is to continue to provide innovative personal protective equipment that helps our customers maintain workforce safety. You have been identified as a customer that has purchased the Miller SkyGrip Temporary Horizontal Lifeline System that were manufactured by Honeywell between **2010-2018**. Honeywell has identified a potential issue with the rebar base assembly, particularly, the stanchion pocket (see Fig 1 below) that may cause the product to not operate to specification.

Step 1. Visually inspect the rebar base assembly stanchion pocket for a complete five-surface weld of the pocket to the base. (See Figure 1).

Figure 1: Picture of properly 5-sided weld stanchion pocket to base

Step 2. If the stanchion pocket is not properly welded on all five sides, to the base, as shown in Figure 1, immediately decommission the use of the of the system base and contact Honeywell Customer Service to arrange a replacement.
