Inspection Notice V-EDGE™ Leading Edge Self-Retracting Lifeline

November 30, 2020

PS20029-02

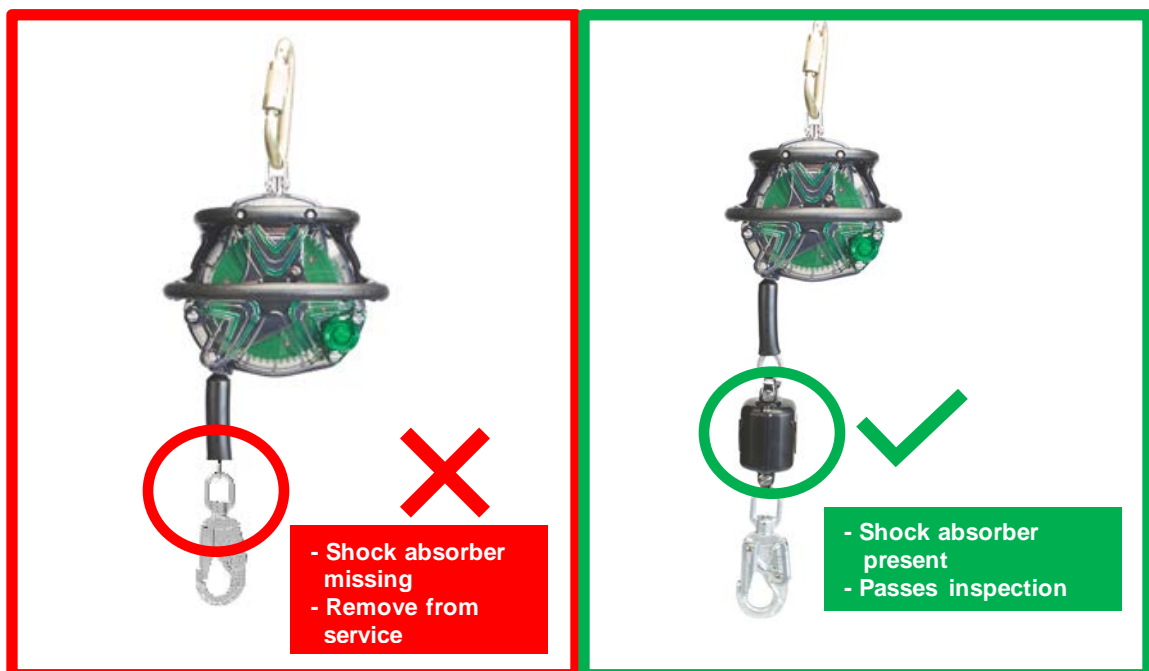
Figure 1 – Shock Absorber Inspection

MSA is issuing this Inspection Notice to inform you that MSA has received field reports of a limited number of MSA V-EDGE™ Leading Edge Self-Retracting Lifelines (SRL) that are missing the external shock absorber. **MSA has not received any reports of injuries associated with this condition. However, we are requesting that you perform the inspection outlined in this notice.**

In the event of a fall, a V-EDGE Leading Edge SRL without an external shock absorber may not correctly absorb the energy created, which may result in greater fall arrest distances that could exceed the published fall clearances. In extreme circumstances, there may be insufficient internal energy absorption to prevent the cable from being severed by a leading edge.

Inspect per the Instructions in this Notice. Remove from service any SRL that does not pass the inspection.

- 1) Confirm that the part number is 63406-00A, 63406-00ACA or 63406-00AEU. Reference Figure 2. If your SRL is **not** one of these part numbers, no further action is needed. If your SRL is one of these part numbers, proceed to step 2.
- 2) Confirm that the manufacturing date marked on the unit is 06/20, 07/20, 08/20 or 09/20. If the manufacturing date is **not** in this range, no further action is needed. If the manufacturing date is in this range, proceed to step 3.
- 3) Inspect for the shock absorber per Figure 1. If the shock absorber is not present, remove the SRL from service.

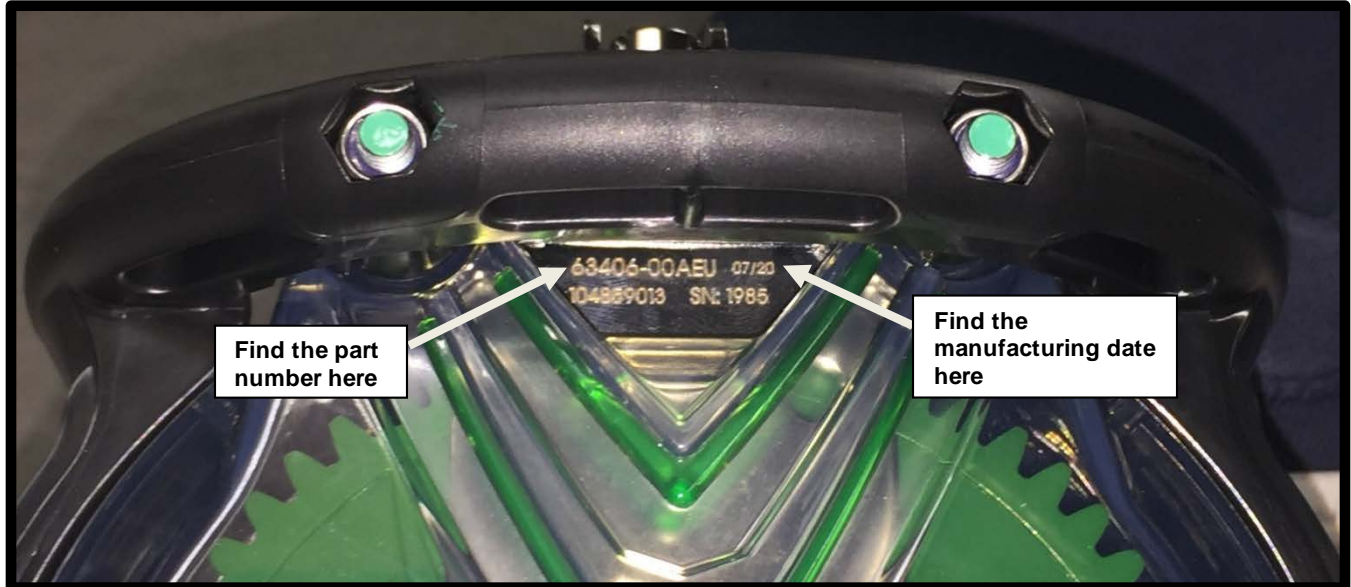
Figure 2

Our investigation has determined that potentially affected SRLs part numbers 63406-00A, 63406-00ACA and 63406-00AEU that were manufactured between June 30 and September 8, 2020.

MSA is advising all customers to confirm the presence of an external shock absorber for MSA V-EDGE Leading Edge SRLs of part number 63406-00A, 63406-00ACA or 63406-00AEU that are marked with a manufacturing date from 06/20 through and including 09/20.
