Immediate Action Required

Specific 3M™ Protecta® Construction & Vest Style Harnesses

3M Fall Protection is issuing an **“Inspection Notice”** on the part numbers found in the appendix

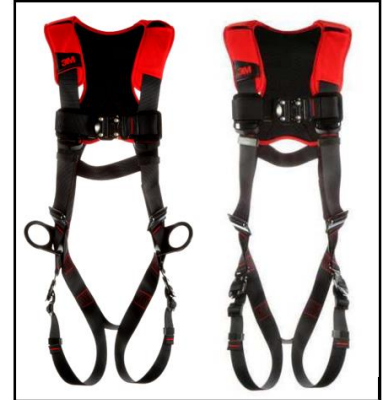
Step 2: Locate the label on the harness (see photograph to right) to determine the model number and if it was manufactured between **October 1, 2021** and **November 1, 2022**. If the harness is an impacted model and was manufactured in the affected date range, please continue to Step 3.

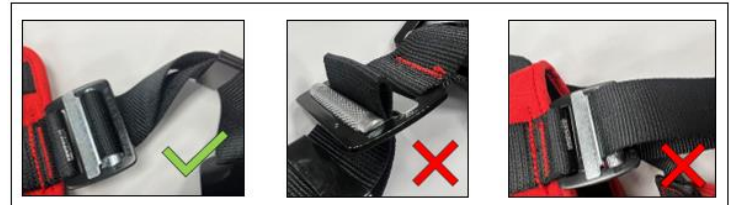
3M Fall Protection has identified a limited number of Protecta Harnesses where the harness webbing is not routed through the adjuster. This condition results in the adjuster not being able to be adjusted or does not lock in place after adjustments have been made. The assembly error is believed to affect only a limited number of units and has been corrected.

Step 3: Once you have confirmed the part number & affected date, inspect the torso adjusters to ensure the webbing is properly routed through the adjuster, as shown in the images right. If the harness passes the inspection, it is acceptable for use. If the harness does not pass inspection, contact our Customer Service Department to arrange to have the harness replaced, as per our standard warranty.

Step 1: Remove product from service until inspection is performed.
