Inspection Notice
MSA WORKMAN® MINI PFL
MSA V-EDGE™ WEB 8ft/2.4m PFL

October 30, 2019

MSA is issuing this Inspection Notice to inform you that MSA has received a limited number of field reports in which the lifeline in a WORKMAN MINI PFL did not retract after being fully extended.

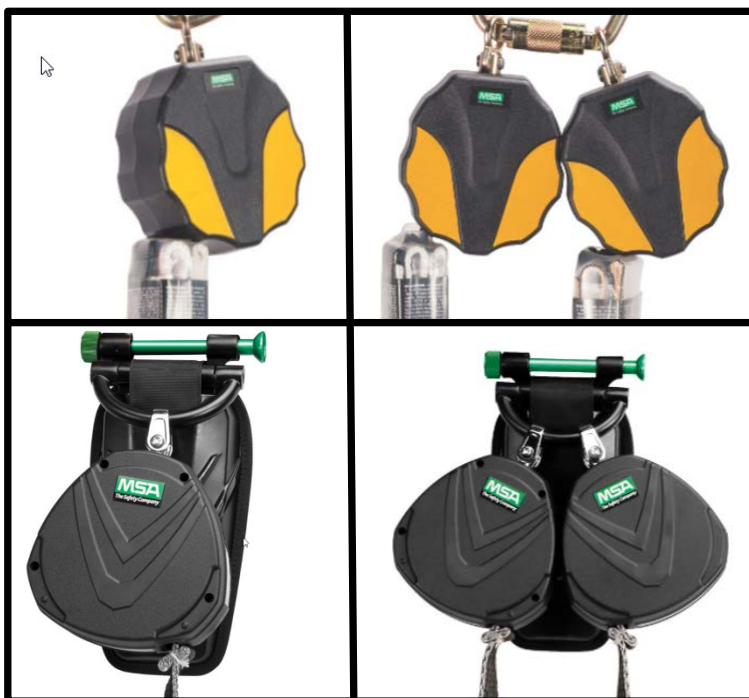
WORKMAN MINI PFL – Single and Twin Leg

V-EDGE WEB 8ft/2.4m PFL – Single and Twin Leg

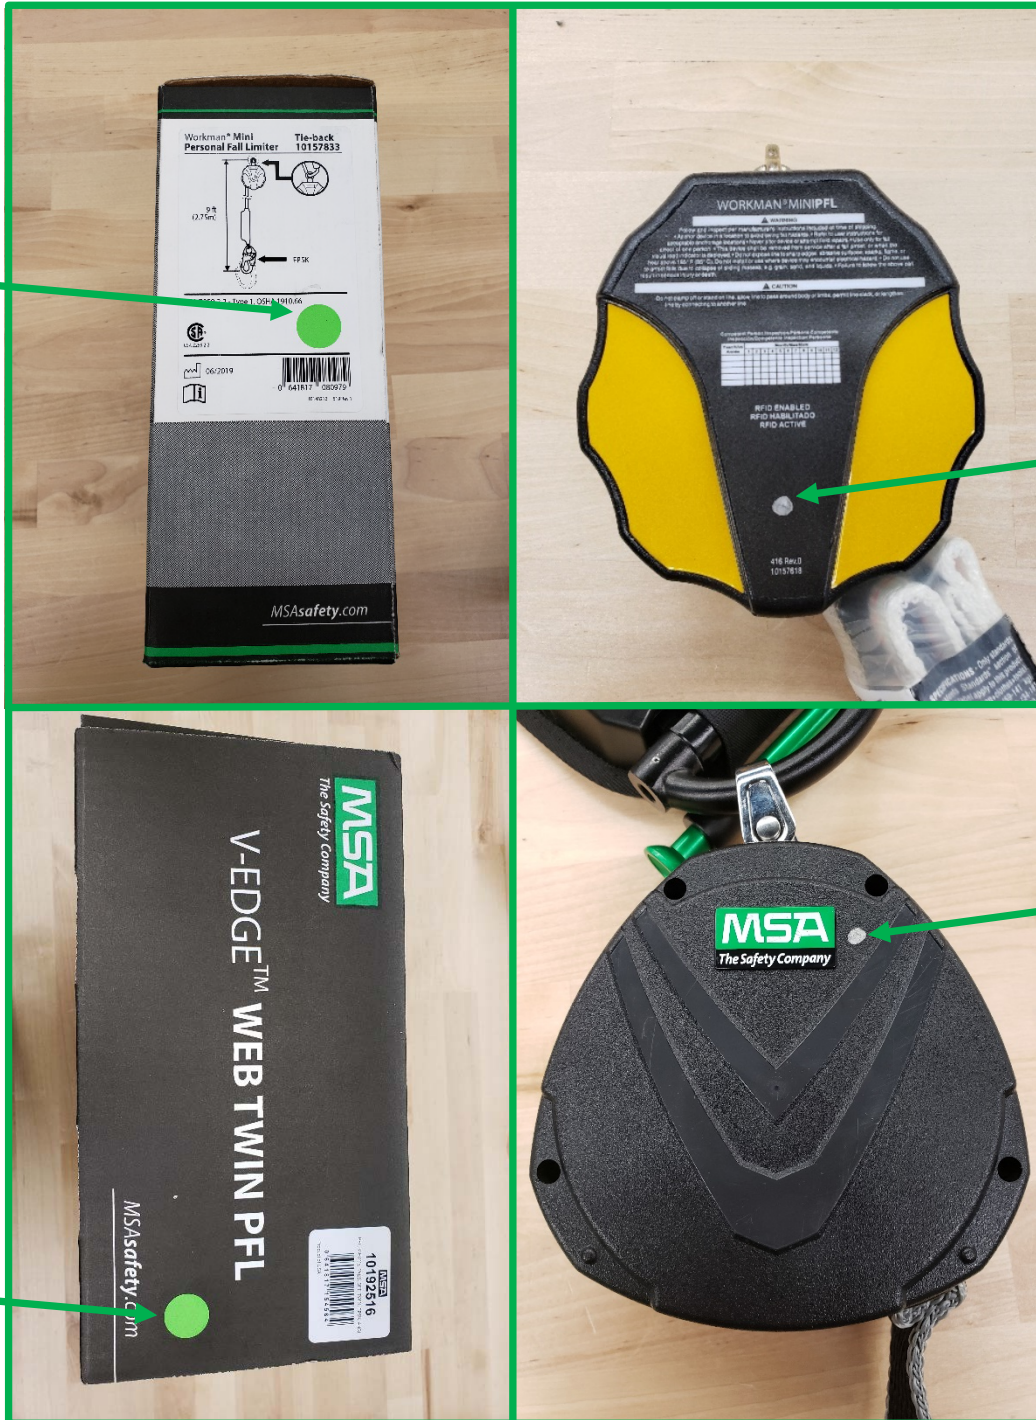
Figure 1 – Markings on MSA Inspected Product

- 1) If your PFL has a green dot on the box or a silver dot on the PFL body (see Figure 1), the unit has been inspected by MSA and this Inspection Notice does not apply.
- 2) Pull out the **full length** of line as required to inspect the webbing per the Inspection Procedure (Section 10.2) of the WORKMAN MINI Personal Fall Limiter User Instructions and the Pre-use checks in the V-EDGE Personal Fall Limiter (PFL) User Instructions.
- 3) While the line is fully pulled out, visually inspect for the webbing termination (See Figure 2).
- 4) Let the lifeline retract back into the housing in a controlled manner.

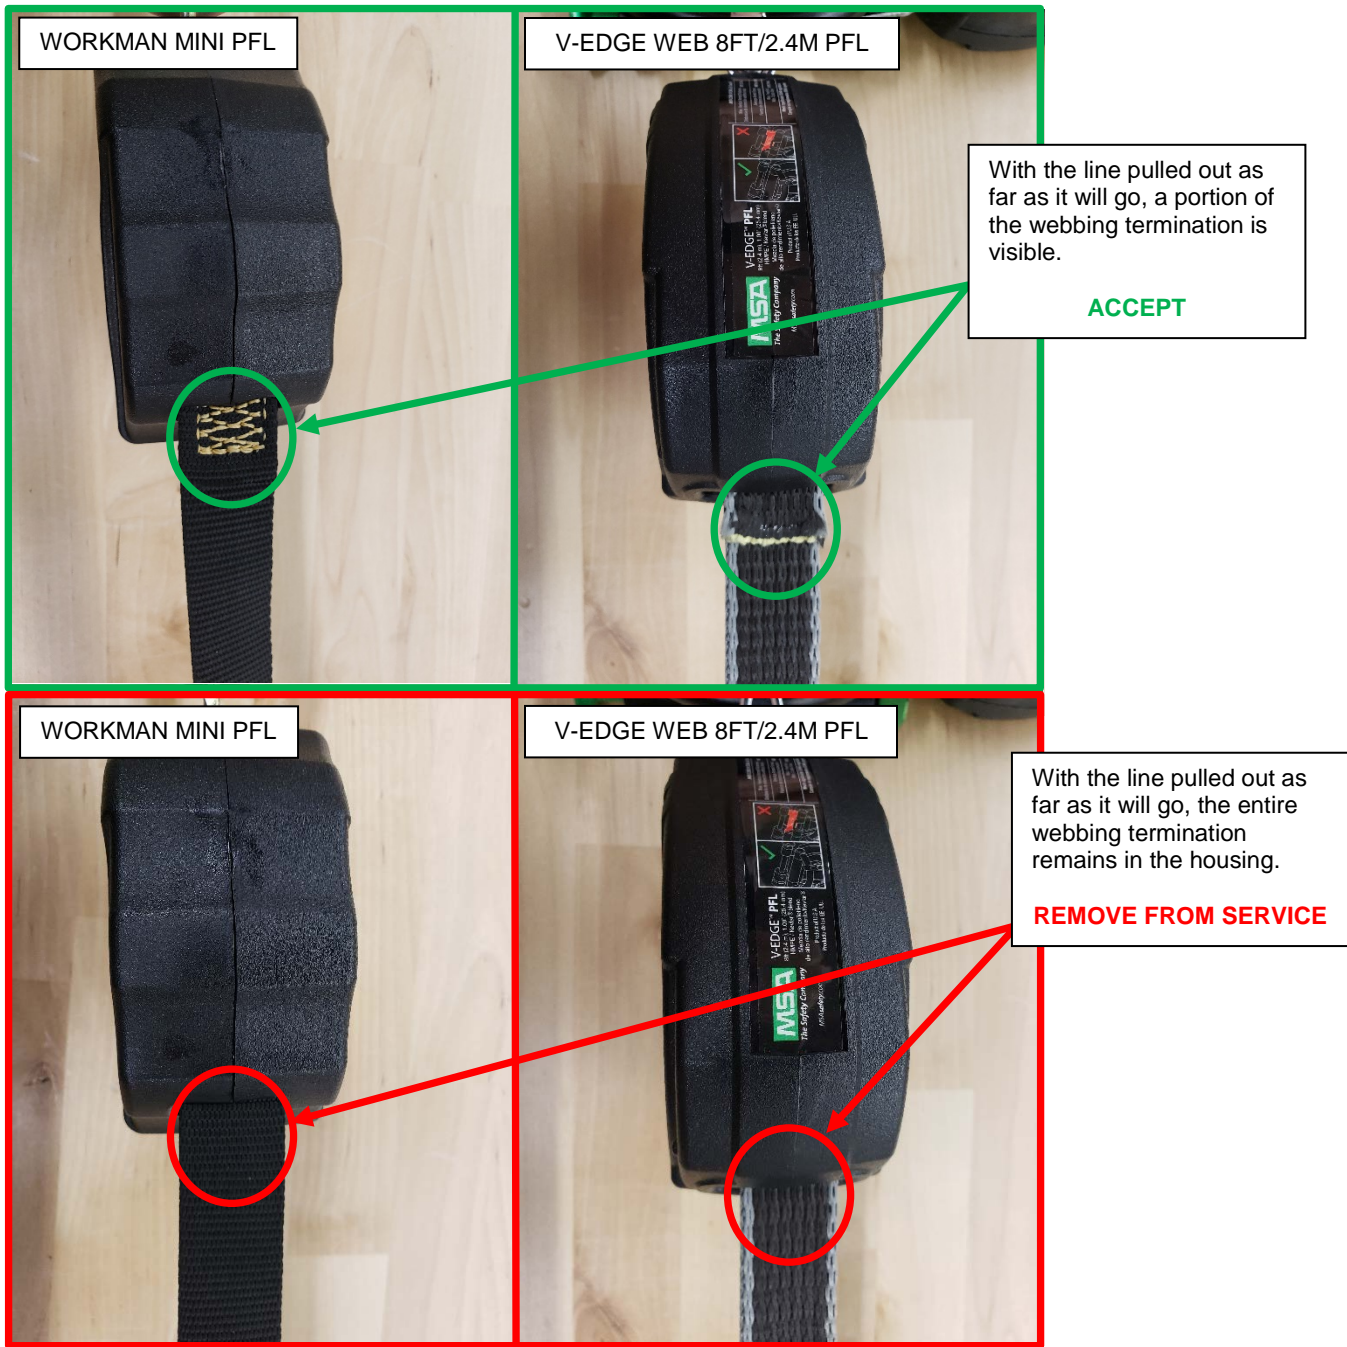
Figure 2 – Webbing Termination

The PFL passes this inspection if any portion of the webbing termination is visible and the line operation is smooth without jerking during extraction or stalling during retraction.

Remove from service, render unusable and dispose of any PFL that does not pass the inspection.
